Progress Report No. 33 for period ending January 31, 2007; Pond 2 Final Closure - Apex Site, Washington

County, Utah

Annual Site Inspection Summary Sheet - Apex Site - Pond 2

Surface Monument Survey Data Review - Apex Site

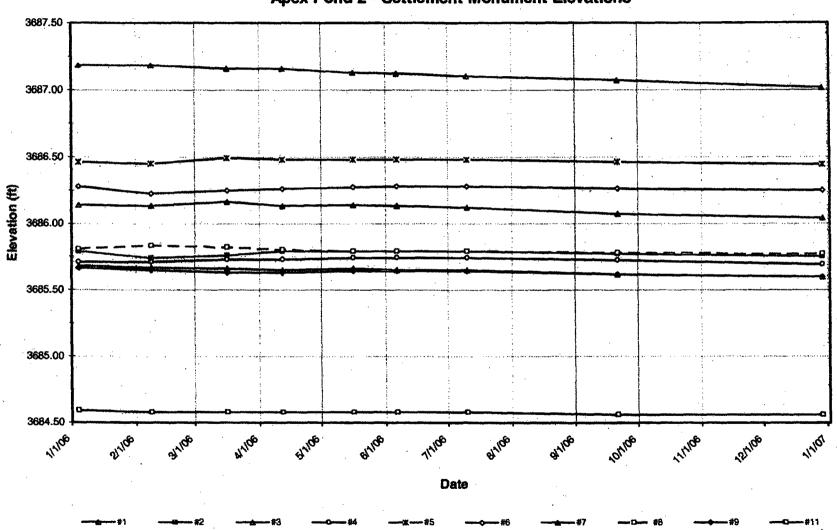
Apex Pond 2 - Settlement Monument Elevations

The elevation at Monument #7 (near the impoundment center) decreased the most (1.9 inches) during 2006. Interestingly, the elevation at monument #11, which is the nearest monument to #7, and is also located near the center, decreased a total of only 0.36 inches over that same time period. Slightly greater settlement in and nearer the center of the impoundment is to be expected as significant quantities of fill were placed in this area during construction.

Elevations at Monuments #4 and #5 on the southwest side of the impoundment have decreased the least (0.24 inches). The average decrease in elevation for all 10 monuments is 0.72 inches.

Based on data collected to date, MEI recommends that Hecla continue with their current plan and collect elevation data quarterly. Please call or email me if you have any questions concerning this review.

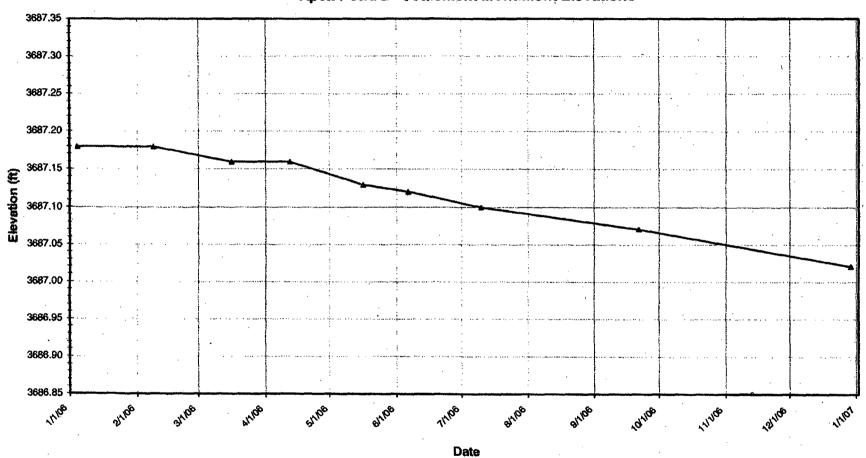
Apex Pond 2 - Settlement Monument Elevations

____#7
